# Naval Surface Warfare Center Carderock Division

NSWCCD-TR-65-97/18 April 1997

# An Experimental Investigation of the Ultimate Strength of Stiffened Panels

- Volume 1, Results and Analyses

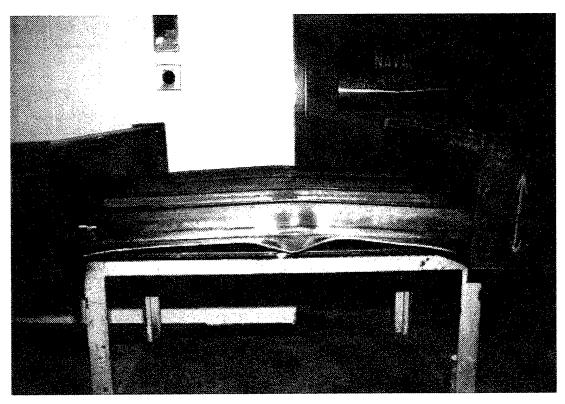
Figure 13c - Side View of Grillage 0494 after Collapse

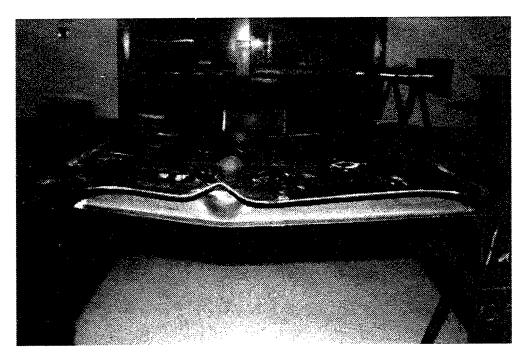
Figure 18c - Grillage 0894 - View of the Plate Side

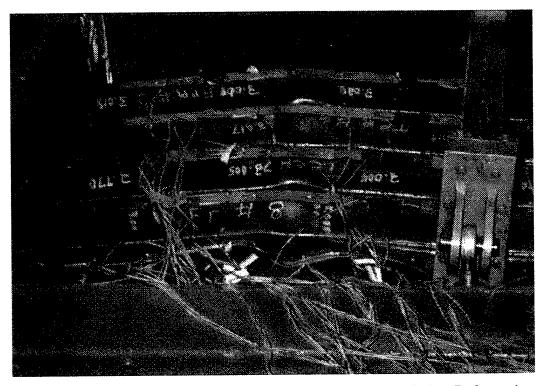
pattern of deformation experienced by the stiffeners and the plating. Figure 28c is a detail of the deflection pattern. Note how the pattern alternates across the grillage and how the web of the stiffeners are affected by the plate deformation. The failure of the stiffener flanges in the forward bay can be seen in Figure 28d. The combination of the fixed end boundary conditions at the grillage ends and the upward deflection of the stiffeners in the center bay put the stiffener flanges in the end bays in compression and cause a local buckling mechanism.

Figure 28b - Center Bay of Grillage 0595 Showing Stiffener and Plate Deformation
